Grand Lake Shoreland Assessment Summary 2011-2013

Funded by the Minnesota Department of Natural Resources

Assessment Conducted by the Sauk River Watershed District

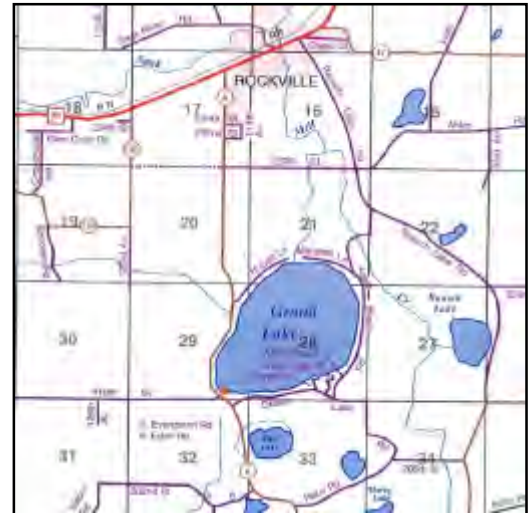
Figure 1 **Grand Lake near Rockville**

Grand Lake is a fully developed, recreational lake located two miles south of Rockville, MN. It has a surface area of 666 acres with a maximum depth of 34 feet. The lake is almost round in shape with little bottom structure (see Figure 1). Approximately 175 year round homes and seasonal cabins surround the lake. In 2005, the City of Rockville annexed this area into the city limits and installed a municipal sewer system around Grand Lake. The municipal sewer system aided in the change over from seasonal cabins to permanent residency, which has increased the use of the lake and the activity along the shoreline.

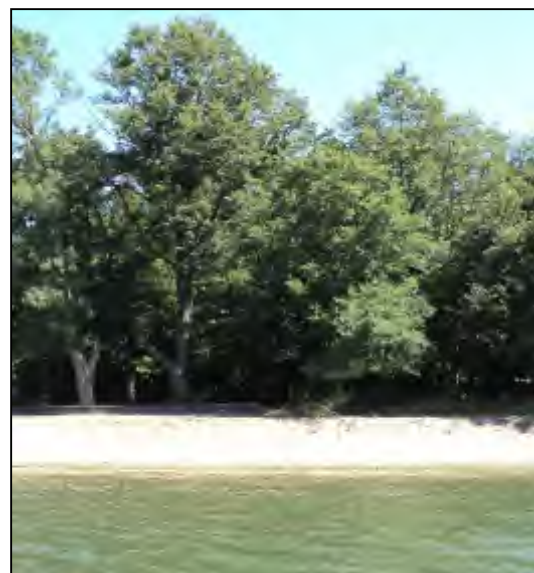
Figure 6

The shoreline zone is defined as the portion of the lakeshore zone between the upland and the water (Figure 4). This zone begins at the bank top and extends to the land-water interface linking the upland and aquatic ecosystems. The shoreland zone works as a buffer which provides a natural shield against erosion and prevents nutrients and other unwanted runoff substances from reaching the water. The SRWD assessed each parcel for evidence of trees, shrubs and overall ground cover. Points were issued based on the percentage of the lot that was occupied by each type of cover. The shoreline zone had a total score of 35 points. Figure 5 identifies 49 parcels with a score of 20 or greater and 97 parcels scoring less than 10. The remaining 29 parcels scored in the middle range (10.1-20.1). The 97 parcels having less than 10 points each make up 9,628 feet of lakeshore, which is 49.3% of the total lakeshore. This indicates that only 50% of the lakeshore of Grand Lake has an established shoreland habitat.

UPLAND ZONE ASSESSMENT RESULTS

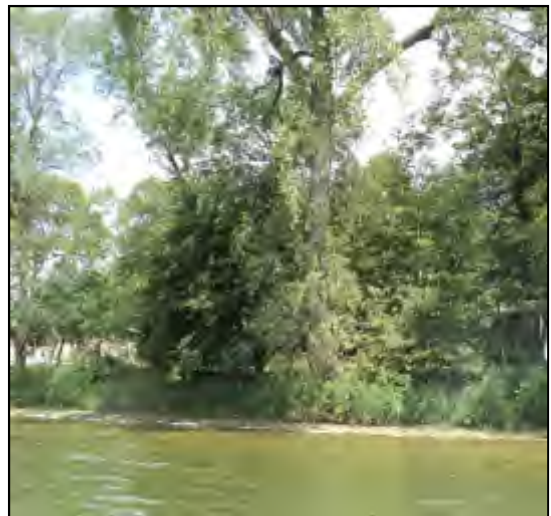
Figure 7

The upland zone includes the majority of the lakeshore lot, beginning at the top of the bank and extending landward to the house or cabin on the lot (Figure 4). This terrestrial zone is the primary habitat for many upland and semi-aquatic species and is essential for their survival. It provides the critical habitat for nesting, feeding and growth. When upland zones around lakes are developed for residential homes or cabins, trees and other vegetation are removed to open a site for buildings. Generally at this time an area of land adjacent to the building is also cleared for a manicured lawn. The upland zone of each parcel on Grand Lake was assessed for tree cover, shrub cover and ground cover. The highest possible score for the upland zone was 65 points. Thirteen parcels scored greater than 40 points, 22 parcels scored in the middle range and 140 parcels scored less than 20 points. The 140 parcels scoring less than 20 points cover 14,324 feet, or 73.3% of lakeshore on Grand Lake. This indicates that the majority of the total lakeshore does not have an established upland habitat for terrestrial and semi-aquatic species.

CUMULATIVE RESULTS FOR ALL ZONES
